**Flood Control Project Maintenance
Levee Inspections**

Fall 2016 Levee Maintenance Deficiency Summary Report

Sacramento River Basin

NA0001	Overall LMA Rating	Total LMA Miles						
American River Flood Control District	A	34.47						
Rated Item	Maintenance Deficiency				Enforcement		Design & System Obsolescence	
	M Miles	U Miles	M + 4U Miles	Threshold %	M Miles	U Miles	M Miles	U Miles
<i>Earthen Levee</i>								
Vegetation	0.05		0.05	0.15%	0.73	0.38		
Encroachments					1.07	3.34		
Animal Control	0.02		0.02	0.06%				
Slope Stability	0.08		0.08	0.23%				
<i>Supplemental</i>								
2015 USACE Erosion Survey, DRAFT	0.04		0.04	0.12%				
DWR UCIP Field Study					0.96	0.07		
<i>LMA Totals:</i>	0.19	0.00	0.19	0.55%	2.76	3.79	0.00	0.00
Unit No. 01 Arcade Creek LB	Overall Unit Rating	Total Unit Miles						
NA0001	A	2.08						
Rated Item	Maintenance Deficiency				Enforcement		Design & System Obsolescence	
	M Miles	U Miles	M + 4U Miles	Threshold %	M Miles	U Miles	M Miles	U Miles
<i>Earthen Levee</i>								
Vegetation	0.01		0.01	0.48%	0.04	0.03		
Encroachments					0.30	0.27

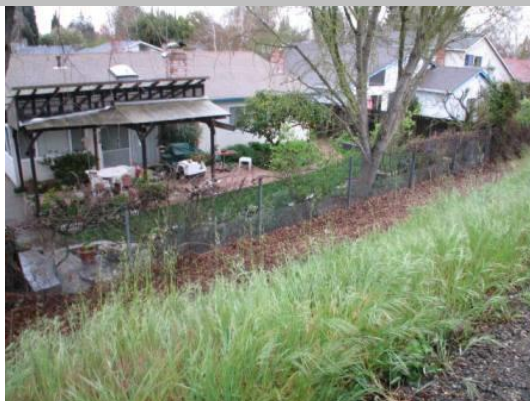
Photo 1 of 1 : FA_2016_NA0001_55_155_20160914_00134.jpg

LM Start	10.59	Rating **	M	Issue No.	155
LM End	10.59	Issue Type +	En	Location *	LS
Category	Earthen Levee			GPS Latitude/Longitude	
				Start	End
Item	Vegetation			38.568892 °	38.568892 °
				-121.353162 °	-121.353162 °
DWR ID	DWR_NA0001_04_s_2012_155				
Comment Code					
V6 : Landscaping					
Inspector Comment					
Trees and bushes are within 10-ft of the levee toe.

03/16/2012 Trees and bushes within 10' of levee toe.

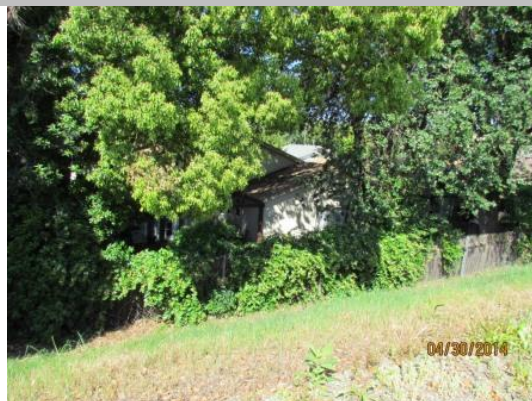
Photo 1 of 1 : FA_2016_NA0001_55_156_20160914_00135.jpg

LM Start	10.60	Rating **	U	Issue No.	156
LM End	10.60	Issue Type +	En	Location *	LS
Category	Earthen Levee			GPS Latitude/Longitude	
				Start	End
Item	Encroachments			38.568713 °	38.568713 °
				-121.353150 °	-121.353150 °
DWR ID	DWR_NA0001_04_s_2012_156				
Comment Code					
FE : Fence					
Inspector Comment					
Wooden privacy fence and landscaping within 10-ft of levee toe.

View of the fence at the landside levee toe obstructing visibility and access.

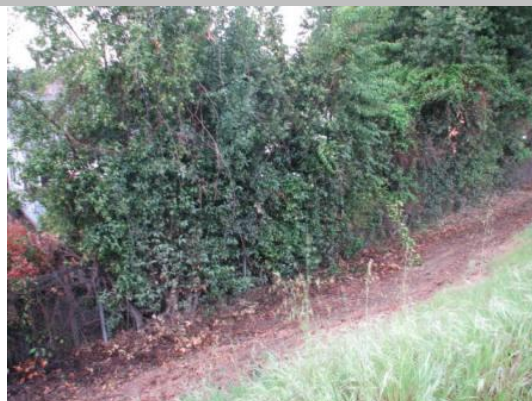
Photo 1 of 1 : FA_2016_NA0001_55_157_20160914_00136.jpg

LM Start	10.61	Rating **	M	Issue No.	157
LM End	10.61	Issue Type +	En	Location *	LS
Category	Earthen Levee			GPS Latitude/Longitude	
				Start	End
Item	Vegetation			38.568608 °	38.568608 °
				-121.353054 °	-121.353054 °
DWR ID	DWR_NA0001_04_s_2012_157				
Comment Code					
V6 : Landscaping					
Inspector Comment					
Tall hedge and vine on levee toe.

03/16/2012 Landscaping obstructs visibility

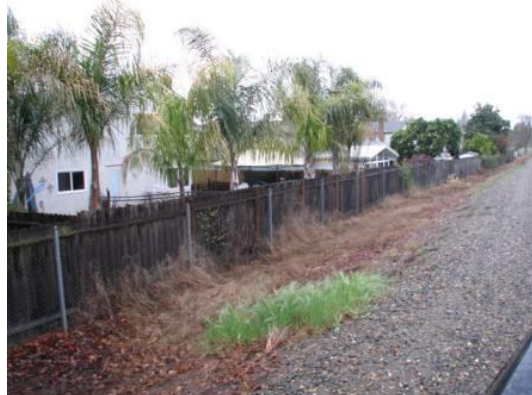
Photo 1 of 1 : FA_2016_NA0001_55_166_20160914_00144.jpg

LM Start	10.75	Rating **	U	Issue No.	166
LM End	10.75	Issue Type +	En	Location *	LS
Category	Earthen Levee			GPS Latitude/Longitude	
				Start	End
Item	Encroachments			38.566705 °	38.566705 °
				-121.352063 °	-121.352063 °
DWR ID	DWR_NA0001_04_s_2012_166				
Comment Code					
FE : Fence					
Inspector Comment					
Wooden privacy fence within 10-ft of levee toe.

03/16/2012 Wood privacy fence completely obstructs access and visibility.

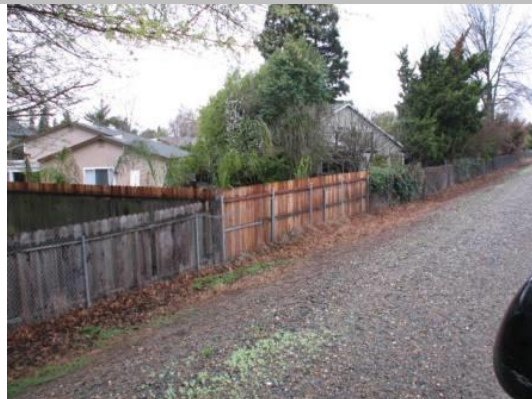
Photo 1 of 1 : FA_2016_NA0001_55_165_20160914_00143.jpg

LM Start	10.80	Rating **	U	Issue No.	165
LM End	10.80	Issue Type +	En	Location *	LS
Category	Earthen Levee			GPS Latitude/Longitude	
				Start	End
Item	Encroachments			38.566044 °	38.566044 °
				-121.351747 °	-121.351747 °
DWR ID	DWR_NA0001_04_s_2012_165				
Comment Code					
FE : Fence					
Inspector Comment					
Wooden privacy fence within 10-ft of levee toe.

03/16/2012 Wood privacy fence completely obstructs access and visibility.

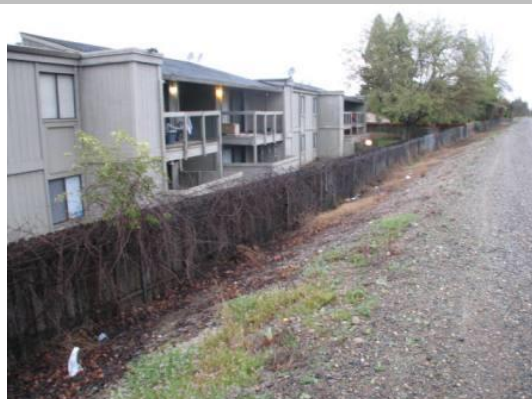
Photo 1 of 1 : FA_2016_NA0001_55_168_20160914_00146.jpg

LM Start	10.81	Rating **	U	Issue No.	168
LM End	10.83	Issue Type +	En	Location *	LS
Category	Earthen Levee			GPS Latitude/Longitude	
				Start	End
Item	Encroachments			38.565917 °	38.565646 °
				-121.351682 °	-121.351532 °
DWR ID	DWR_NA0001_04_s_2012_168				
Comment Code					
FE : Fence					
Inspector Comment					
Wooden privacy fence within 10-ft of levee toe.

03/16/2012 Wood privacy fence completely obstructs access and visibility.

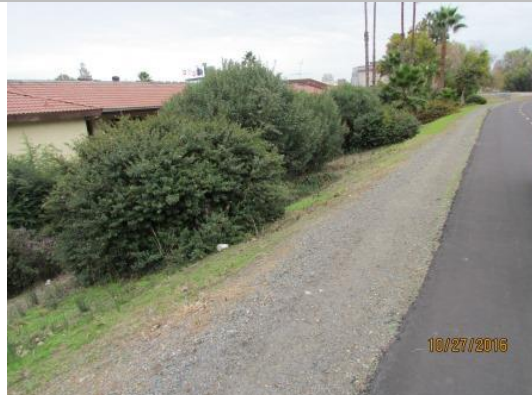
Photo 1 of 1 : FA_2016_NA0001_56_2_20161031_00004.jpg

LM Start	0.10	Rating **	U	Issue No.	2
LM End	0.17	Issue Type +	En	Location *	LS
Category	Earthen Levee			GPS Latitude/Longitude	
				Start	End
Item	Vegetation			38.595044 °	38.594117 °
				-121.506497 °	-121.506377 °
DWR ID	DWR_NA0001_05_s_2012_2				
Comment Code					
V6 : Landscaping					
Inspector Comment					
Landcaping behind Best Western.

View of the landscaping on the landside levee slope obstructing visibility and access.

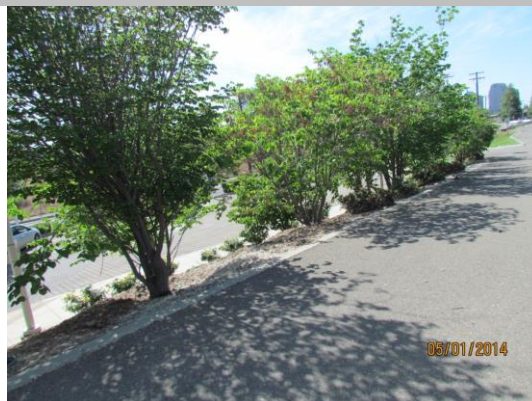
Photo 1 of 1 : FA_2016_NA0001_56_5_20160914_00003.jpg

LM Start	0.27	Rating **	M	Issue No.	5
LM End	0.35	Issue Type +	En	Location *	LS
Category	Earthen Levee			GPS Latitude/Longitude	
				Start	End
Item	Vegetation			38.592630 °	38.591517 °
				-121.505850 °	-121.505447 °
DWR ID	DWR_NA0001_05_s_2012_5				
Comment Code					
V6 : Landscaping					
Inspector Comment					
Landscaping at City intake facility.

View of the landscaping on the landside levee slope at the City intake facility.

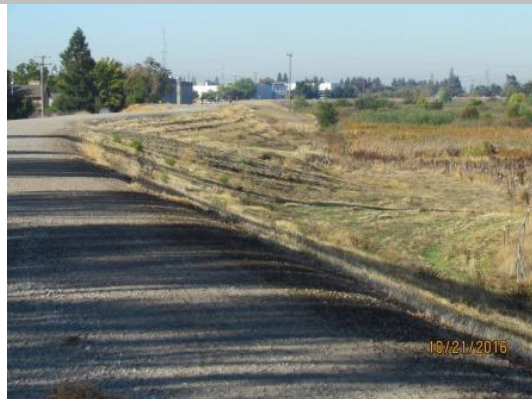
Photo 1 of 1 : FA_2016_NA0001_57_8_20161031_00007.jpg

LM Start	0.04	Rating **	A	Issue No.	8
LM End	0.83	Issue Type +	Ma	Location *	WS
Category	Earthen Levee			GPS Latitude/Longitude	
				Start	End
Item	Vegetation			38.657360 °	38.661122 °
				-121.474031 °	-121.460586 °
DWR ID	DWR_NA0001_06_f_2016_8				
Comment Code					
V1 : Control annual grass and weeds on the levee slopes and easements.					
Inspector Comment					
Acceptable vegetation control.

View of the vegetation on the waterside levee slope.

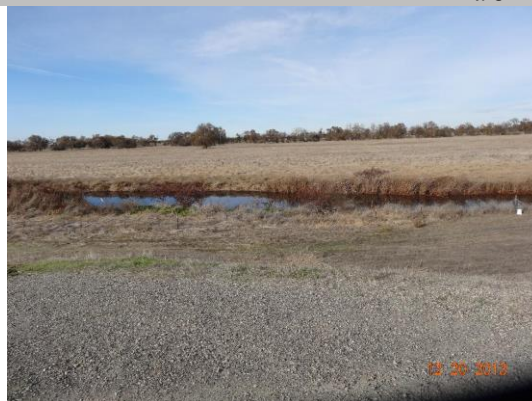
Photo 1 of 2 : UCIP_FA_2016_30706_56559.jpg

LM Start	0.75	Rating **	M	Issue No.	10
LM End	0.75	Issue Type +	En	Location *	WS
Category	Supplemental			GPS Latitude/Longitude	
				Start	End
Item	DWR UCIP Field Study			38.660518 °	38.660518 °
				-121.461826 °	-121.461826 °
DWR ID					
Comment Code					
Inspector Comment					
FS_ID:30706 DS_ID:24812 EP_NO: N/A Repair Type: Non-Urgent Crossing Status: Indicator Found UCIP Comments: Unable to confirm if line goes through levee or along landward slope. No permit found. FIELD_STRUCT_DESC: Storm drain manhole located on landside (LS). FS Date: 12/20/2013

View of waterward side.

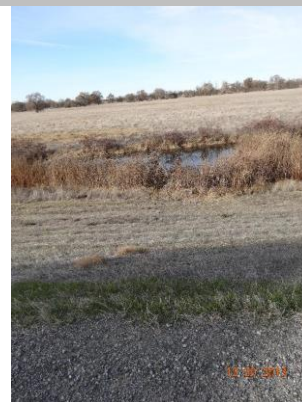
Photo 1 of 2 : UCIP_FA_2016_29223_54002.jpg

Comment Code					
Inspector Comment					
FS_ID:29223					
DS_ID:24354					
EP_NO: N/A					
Repair Type: Non-Urgent					
Crossing Status: Indicator Found					
UCIP Comments: Unable to find CM riser and flap gate on waterward end--need to contact owner to determine status of crossing. Manhole found on landward side however unable to determine if manhole is part of this crossing.					
FIELD_STRUCT_DESC: 24-inch pipe through the levee, 12.5 feet below the crown. Two corrugated metal (CM) cutoff walls around pipe. Slide gate in CM riser and flap gate at waterside (WS) end. Concrete headwalls on both ends. (USACE-1959). This entry matches the Drainage or Irrigation Structure referenced in O&M manual (Station 440+50).					
FS Date: 12/20/2013

View of waterward side--no evidence of crossing.

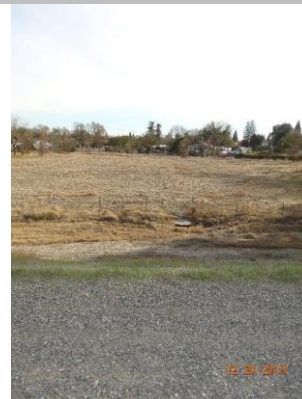
Photo 2 of 2 : UCIP_FA_2016_29223_54001.jpg

Comment Code						
Inspector Comment						
FS_ID:29223 DS_ID:24354 EP_NO: N/A Repair Type: Non-Urgent Crossing Status: Indicator Found UCIP Comments: Unable to find CM riser and flap gate on waterward end--need to contact owner to determine status of crossing. Manhole found on landward side however unable to determine if manhole is part of this crossing. FIELD_STRUCT_DESC: 24-inch pipe through the levee, 12.5 feet below the crown. Two corrugated metal (CM) cutoff walls around pipe. Slide gate in CM riser and flap gate at waterside (WS) end. Concrete headwalls on both ends. (USACE-1959). This entry matches the Drainage or Irrigation Structure referenced in O&M manual (Station 440+50). FS Date: 12/20/2013

View of landward side--manhole on landward toe.

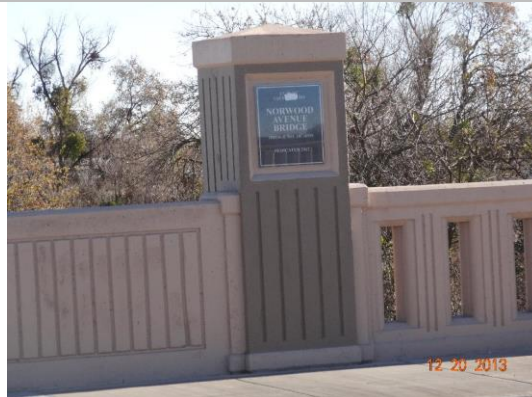
Photo 1 of 2 : UCIP_FA_2016_49931_54061.jpg

FS_ID:49931
DS_ID:24363
EP_NO: 3417
Repair Type: Urgent
Crossing Status: Found
UCIP Comments: 8/11/2016 Markers still missing. LMA representatives, Tim Kerr and Richard Marck, provided permit for PG&E line to be raised to 200-year water surface elevation. Pipe will be raised on both the right and left banks. Depth below the crown will need to be updated once construction is completed. (DWR UCIP - omagana)12/19/2013
Missing gas line markers -- need to contact owner to determine status. (DWR UCIP - omagana)
FIELD_STRUCT_DESC: 4-inch steel gas line through the levee, 2 feet below the crown. Corrugated metal (CM) cutoff wall around pipe at the center of the levee. 4-inch gate valve will be installed on the LS approximately 355 feet from levee crown (near Fairbanks Avenue and Norwood Avenue). (4-inch pipe installed under Permit No. 3417, 1961 - Pacific Gas and Electric Company [PG&E]; 4-inch pipe removed and replaced under Permit 18641, 2011 - PG&E; 4-inch pipe through levee (both right and left bank) raised above the 200-year water surface elevation under Permit No. 18641-1, 2016 - PG&E) [Additional Reference(s): DWR Levee Log, 2002]

Norwood Avenue Bridge

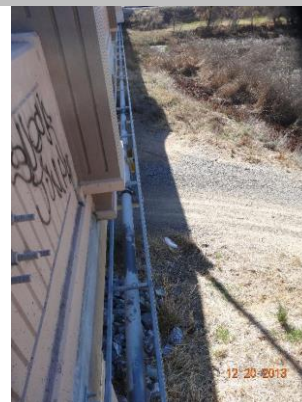
Photo 2 of 2 : UCIP_FA_2016_49931_54062.jpg

View of pipe attached to bridge.

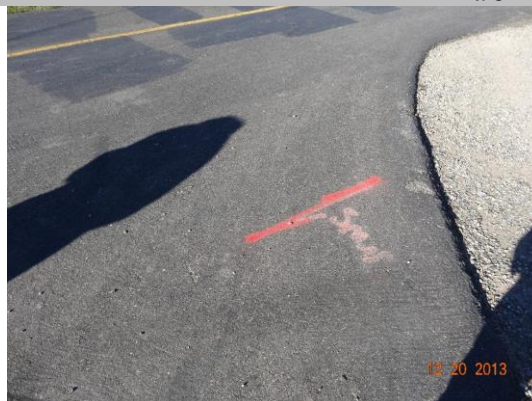
Photo 1 of 2 : UCIP_FA_2016_40803_48512.jpg

LM Start	1.24	Rating **	M	Issue No.	46
LM End	1.24	Issue Type +	En	Location *	WS
Category	Supplemental			GPS Latitude/Longitude	
				Start	End
Item	DWR UCIP Field Study			38.625785 °	38.625785 °
				-121.447464 °	-121.447464 °
DWR ID					
Comment Code					
Inspector Comment					
FS_ID:40803					
DS_ID:24447					
EP_NO: 16466					
Repair Type: Non-Urgent					
Crossing Status: Found					
UCIP Comments: Need to contact owner to determine if crossings are at this location are associated with Permit number 16466--unable to confirm crossings.					
FIELD_STRUCT_DESC: Two 6-inch and one 2-inch concrete encased steel utility conduits through the levee, all approximately 2.0 feet below the crown. Manhole on the levee crown. (Permit No. 16466-1995)					
FS Date: 12/20/2013

Underground Service Alert (USA) marking present on pavement however, unable to verify crossings.

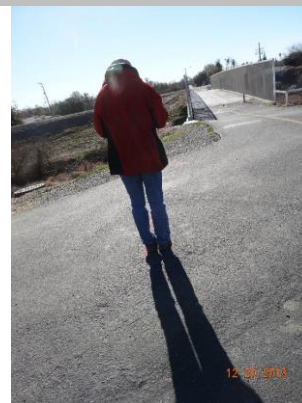
Photo 2 of 2 : UCIP_FA_2016_40803_48511.jpg

View of levee crown and estimate where crossings cross levee.

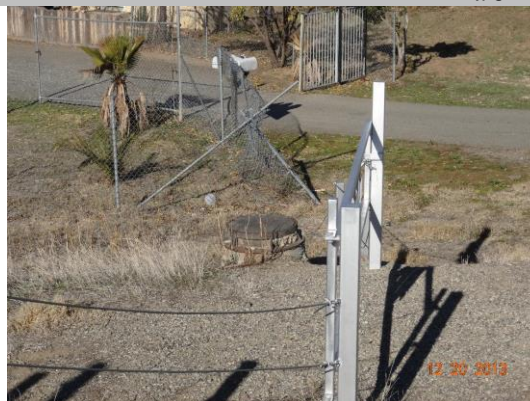
Photo 1 of 1 : UCIP_FA_2016_29275_54199.jpg

LM Start	1.31	Rating **	M	Issue No.	45
LM End	1.31	Issue Type +	En	Location *	WS
Category	Supplemental			GPS Latitude/Longitude	
				Start	End
Item	DWR UCIP Field Study			38.626198 °	38.626198 °
				-121.446321 °	-121.446321 °
DWR ID					
Comment Code					
Inspector Comment					
FS_ID:29275 DS_ID:24553 EP_NO: N/A Repair Type: Non-Urgent Crossing Status: Found UCIP Comments: Only manhole present--need to coordinate with owner to determine if crossing is still presnt and whether manhole corresponds to this crossing. FIELD_STRUCT_DESC: 8-inch (not 10-inch as indicated in desk study) sewer pipe through the levee, 7.5 feet below the crown. Floodgates within the levee across the channel, installed under Permit No. 14480 (1986). FS Date: 12/20/2013

Manhole visible on landward side.

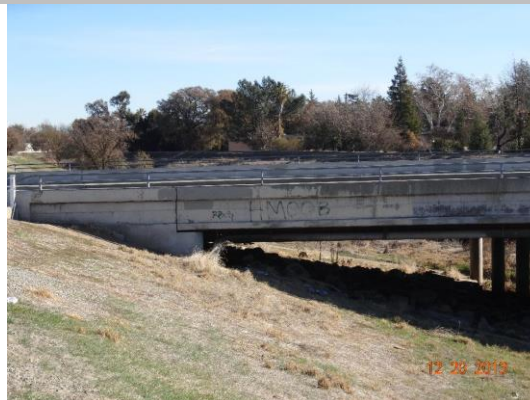
Photo 1 of 2 : UCIP_FA_2016_49933_75853.jpg

Comment Code					
Inspector Comment					
FS_ID:49933 DS_ID:24443 EP_NO: 15152 Repair Type: Urgent Crossing Status: Indicator Found UCIP Comments: 8/11/2016 Markers still missing. Will need to update depth below crown once construction is completed. (DWR UCIP - omagana)12/20/2013 Unable to confirm if crossing is the same one authorized through permit. (DWR UCIP - omagana) FIELD_STRUCT_DESC: 4-inch steel gas main through the levee, 2.5 feet below the crown. Vent is located on the waterside (WS) shoulder. (4-inch line installed under Permit No. 15152, 1989 - Pacific Gas and Electric Company [PG&E]; 4-inch will be raised above the 200-year water surface elevation within the levee crown under Permit No. 15152-1, 2016 - PG&E) FS Date: 8/11/2016

View of WS.

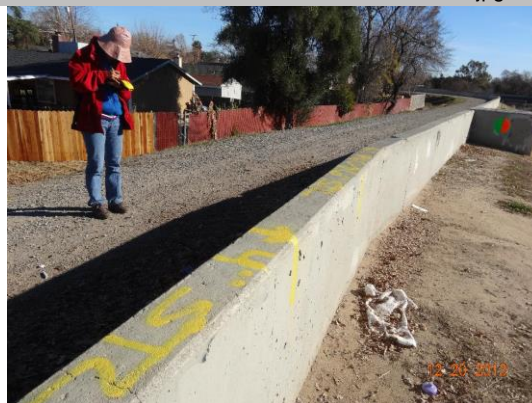
Photo 2 of 2 : UCIP_FA_2016_46795_57525.jpg

LM Start	1.60	Rating **	M	Issue No.	47
LM End	1.60	Issue Type +	En	Location *	LS
Category	Supplemental			GPS Latitude/Longitude	
				Start	End
Item	DWR UCIP Field Study			38.627760 °	38.627760 °
				-121.441593 °	-121.441593 °
DWR ID					
Comment Code					
Inspector Comment					
FS_ID:46795 DS_ID:24835 EP_NO: N/A Repair Type: Non-Urgent Crossing Status: Indicator Found UCIP Comments: 11/12/15 Markers have been installed on both levees--confirmed during 2015 DWR Fall Inspection. Need to coordinate with PG&E to determine permit for this crossing.12/19/13 Gas line - no markers visible. No permit available. FIELD_STRUCT_DESC: 2 of 2: 6-inch pipe through the levee and under the channel at an unknown depth. FS Date: 12/20/2013

Underground service alert (USA) markings visible on floodwall.

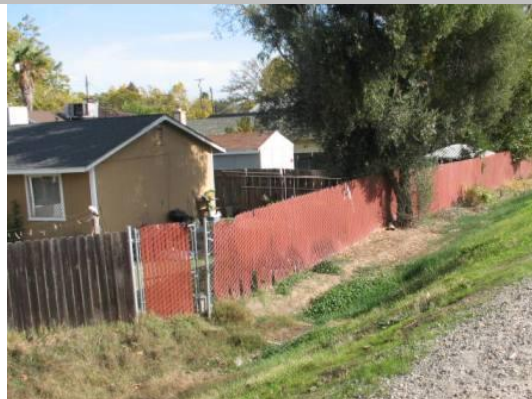
Photo 1 of 1 : FA_2016_NA0001_58_29_20160914_00027.jpg

LM Start	1.61	Rating **	M	Issue No.	29
LM End	1.61	Issue Type +	En	Location *	LS
Category	Earthen Levee			GPS Latitude/Longitude	
				Start	End
Item	Encroachments			38.627733 °	38.627733 °
				-121.441415 °	-121.441415 °
DWR ID	DWR_NA0001_07_s_2012_29				
Comment Code					
FE : Fence					
Inspector Comment					
Privacy fence is within 10-ft of the levee toe.

11/17/2011 Privacy fence is constructed at the toe.

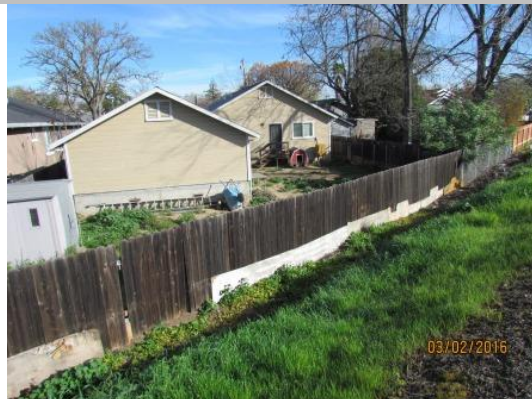
Photo 1 of 1 : FA_2016_NA0001_58_40_20160914_00033.jpg

LM Start	1.66	Rating **	U	Issue No.	40
LM End	1.66	Issue Type +	En	Location *	LS
Category	Earthen Levee			GPS Latitude/Longitude	
				Start	End
Item	Encroachments			38.627727 °	38.627727 °
				-121.440442 °	-121.440442 °
DWR ID	DWR_NA0001_07_s_2016_40				
Comment Code					
FE : Fence					
Inspector Comment

View of the fence at the landside levee toe.

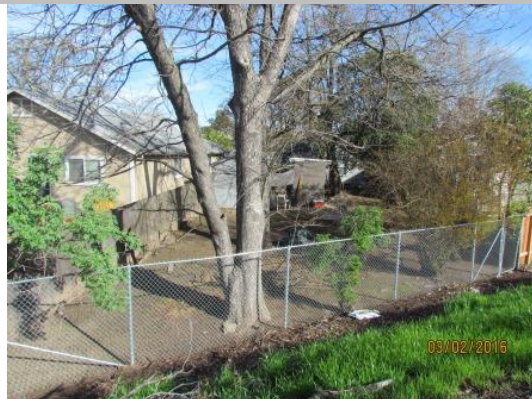
Photo 1 of 1 : FA_2016_NA0001_58_41_20160914_00034.jpg

LM Start	1.67	Rating **	M	Issue No.	41
LM End	1.67	Issue Type +	En	Location *	LS
Category	Earthen Levee			GPS Latitude/Longitude	
				Start	End
Item	Encroachments			38.627803 °	38.627803 °
				-121.440270 °	-121.440270 °
DWR ID	DWR_NA0001_07_s_2016_41				
Comment Code					
FE : Fence					
Inspector Comment

View of the fence at the landside levee toe.

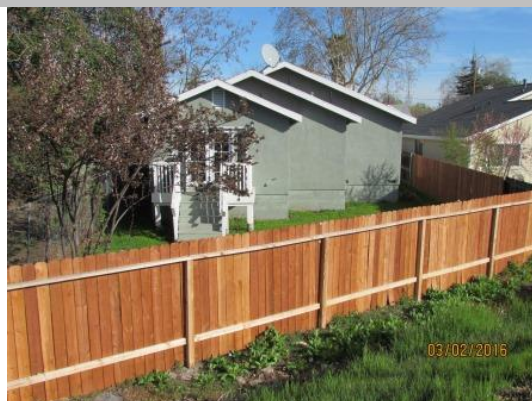
Photo 1 of 1 : FA_2016_NA0001_58_44_20160914_00036.jpg

LM Start	1.68	Rating **	U	Issue No.	44
LM End	1.68	Issue Type +	En	Location *	LS
Category	Earthen Levee			GPS Latitude/Longitude	
				Start	End
Item	Encroachments			38.627874 °	38.627874 °
				-121.440134 °	-121.440134 °
DWR ID	DWR_NA0001_07_s_2016_44				
Comment Code					
FE : Fence					
Inspector Comment

View of the fence at the landside levee toe.

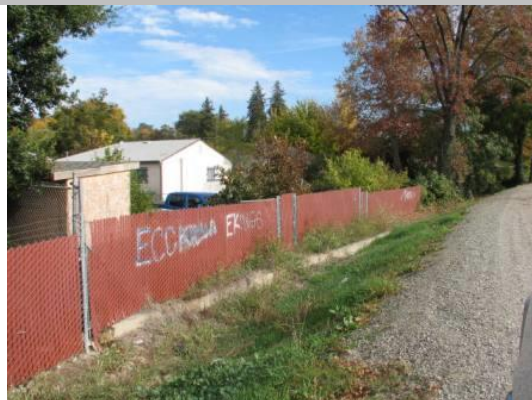
Photo 1 of 1 : FA_2016_NA0001_58_13_20160914_00014.jpg

LM Start	1.82	Rating **	U	Issue No.	13
LM End	1.82	Issue Type +	En	Location *	LS
Category	Earthen Levee			GPS Latitude/Longitude	
				Start	End
Item	Encroachments			38.628303 °	38.628303 °
				-121.437693 °	-121.437693 °
DWR ID	DWR_NA0001_07_s_2012_13				
Comment Code					
FE : Fence					
Inspector Comment					
Chain link privacy fence is within 10-ft of levee toe.

11/17/2011 Privacy fence is located at the toe.

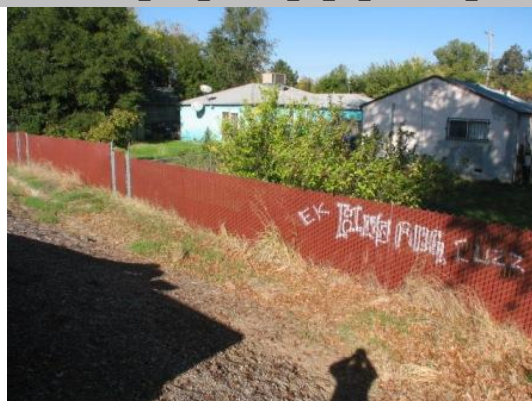
Photo 1 of 1 : FA_2016_NA0001_58_14_20160914_00015.jpg

LM Start	1.83	Rating **	U	Issue No.	14
LM End	1.83	Issue Type +	En	Location *	LS
Category	Earthen Levee			GPS Latitude/Longitude	
				Start	End
Item	Encroachments			38.628303 °	38.628303 °
				-121.437530 °	-121.437530 °
DWR ID	DWR_NA0001_07_s_2012_14				
Comment Code					
FE : Fence					
Inspector Comment					
Chain link privacy fence is within 10-ft of levee toe.

Fall 2009 photo of privacy fence within 10-ft of the levee toe obstructs visibility and access.

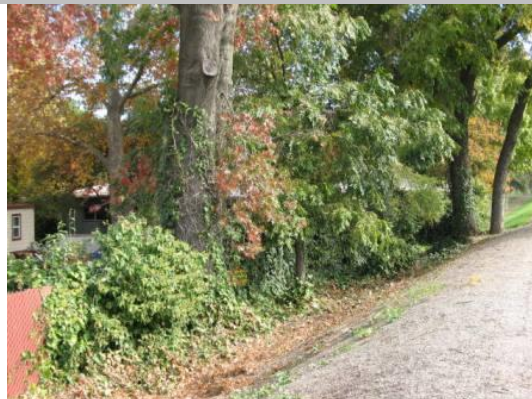
Photo 1 of 2 : FA_2016_NA0001_58_15_20160914_00016.jpg

LM Start	1.84	Rating **	U	Issue No.	15 (cont)
LM End	1.84	Issue Type +	En	Location *	LS

11/17/2011 Dense vegetation at the toe.

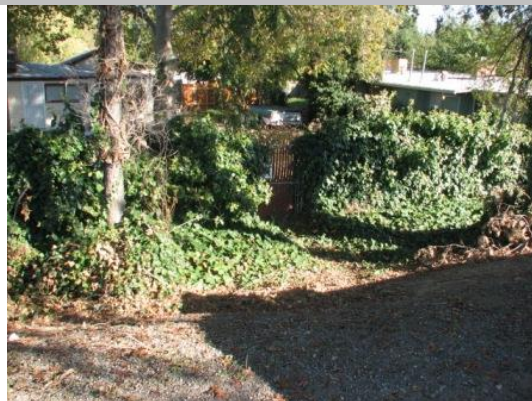
Photo 2 of 2 : FA_2016_NA0001_58_15_20160914_00017.jpg

Fall 2009 photo of dense ivy and fence obstruct visibility and access.

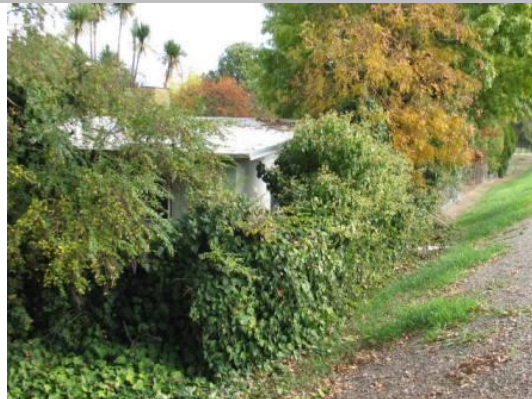
Photo 1 of 1 : FA_2016_NA0001_58_16_20160914_00018.jpg

LM Start	1.86	Rating **	U	Issue No.	16
LM End	1.86	Issue Type +	En	Location *	LS
Category	Earthen Levee			GPS Latitude/Longitude	
				Start	End
Item	Vegetation			38.628262 °	38.628262 °
				-121.436985 °	-121.436985 °
DWR ID	DWR_NA0001_07_s_2012_16				
Comment Code					
V6 : Landscaping					
Inspector Comment					
Dense ivy and trees along chain link fence on levee toe. Large building is within 10-ft of levee toe.

11/17/2011 Vegetation and building obstruct visibility and access to the levee toe.

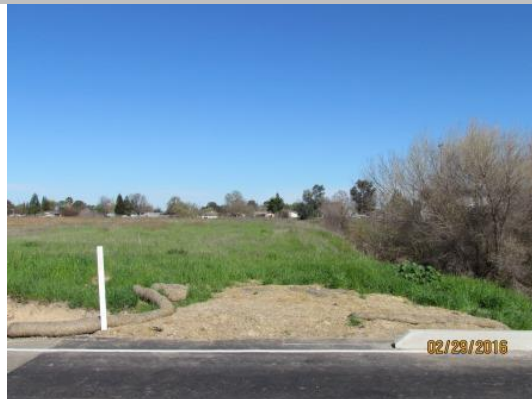
Photo 1 of 1 : FA_2016_NA0001_59_1_20160914_00001.jpg

LM Start	0.51	Rating **	U	Issue No.	1
LM End	1.03	Issue Type +	En	Location *	WS
Category	Earthen Levee			GPS Latitude/Longitude	
				Start	End
Item	Encroachments			38.668132 °	38.665528 °
				-121.438229 °	-121.431688 °
DWR ID	DWR_NA0001_08_s_2012_1				
Comment Code					
MA : Material					
Inspector Comment					
This portion of the levee is inaccessible for maintenance.

View from downstream end of inaccessible portion of Magpie Creek due to landowner restrictions. There is no levee for ARFCD to maintain at this location. However, the channel maintenance is the responsibility of Sacramento Yard, State DWR.

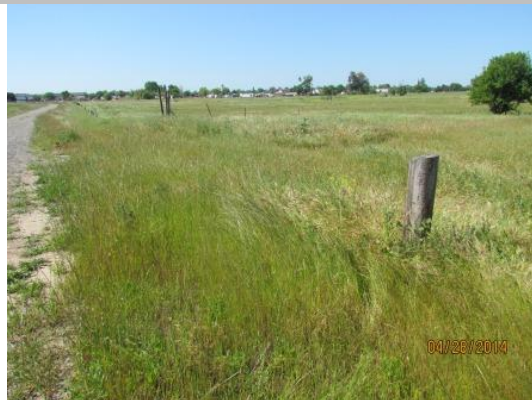
Photo 1 of 1 : FA_2016_NA0001_59_20_20160914_00008.jpg

LM Start	1.21	Rating **	M	Issue No.	20
LM End	1.21	Issue Type +	En	Location *	LS
Category	Earthen Levee			GPS Latitude/Longitude	
				Start	End
Item	Encroachments			38.662860 °	38.662860 °
				-121.431671 °	-121.431671 °
DWR ID	DWR_NA0001_08_s_2014_20				
Comment Code					
PO : Pole					
Inspector Comment

View of the pole on landside levee toe.

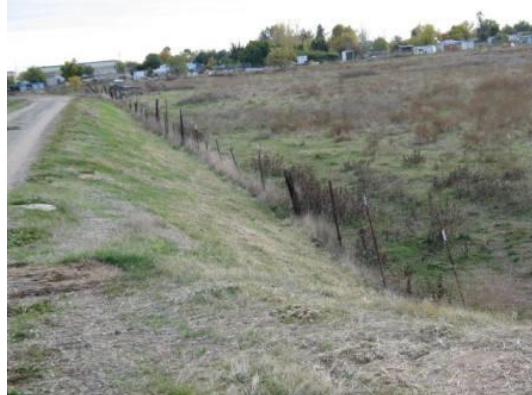
Photo 1 of 1 : FA_2016_NA0001_59_2_20160914_00002.jpg

LM Start	1.22	Rating **	M	Issue No.	2
LM End	1.31	Issue Type +	En	Location *	LS
Category	Earthen Levee			GPS Latitude/Longitude	
				Start	End
Item	Encroachments			38.662715 °	38.661584 °
				-121.431666 °	-121.431402 °
DWR ID	DWR_NA0001_08_s_ 2012_2				
Comment Code					
FE : Fence					
Inspector Comment					
Barbed wire fence runs along the levee toe.

11/17/2011 Barbed wire fence at levee toe.

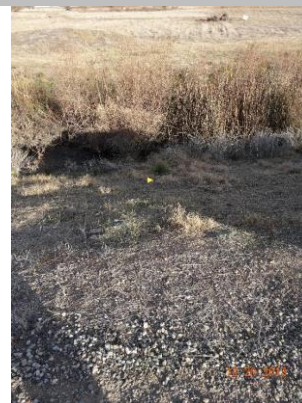
Photo 1 of 2 : UCIP_FA_2016_30689_56509.jpg

LM Start	1.28	Rating **	M	Issue No.	24
LM End	1.28	Issue Type +	En	Location *	LS
Category	Supplemental			GPS Latitude/Longitude	
				Start	End
Item	DWR UCIP Field Study			38.661843 °	38.661843 °
				-121.431675 °	-121.431675 °
DWR ID					
Comment Code					
Inspector Comment					
FS_ID:30689 DS_ID:24815 EP_NO: N/A Repair Type: Non-Urgent Crossing Status: Indicator Found UCIP Comments: unable to confirm if conduit or gas line cross levee or flag identifying problem areas. Need additional information. FIELD_STRUCT_DESC: Underground service alert (USA) markers found on waterside (WS) and landside (LS) during field inspection. FS Date: 12/20/2013

View of waterward side.

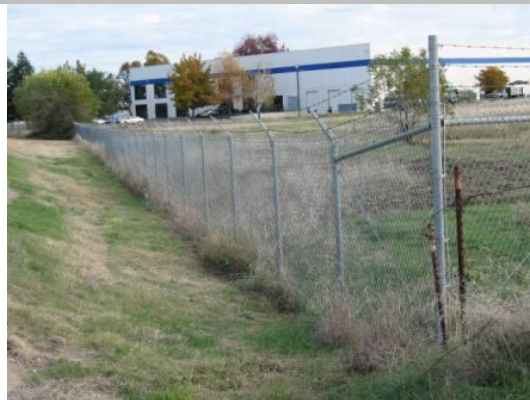
Photo 1 of 1 : FA_2016_NA0001_59_7_20160914_00005.jpg

LM Start	1.30	Rating **	M	Issue No.	7
LM End	1.33	Issue Type +	En	Location *	LS
Category	Earthen Levee			GPS Latitude/Longitude	
				Start	End
Item	Encroachments			38.661593 °	38.661370 °
				-121.431420 °	-121.430943 °
DWR ID	DWR_NA0001_08_s_2012_7				
Comment Code					
FE : Fence					
Inspector Comment					
Cyclone fence with barbed wire within 10' of toe for part of its alignment.

11/17/2011 Chainlink fence at levee toe.

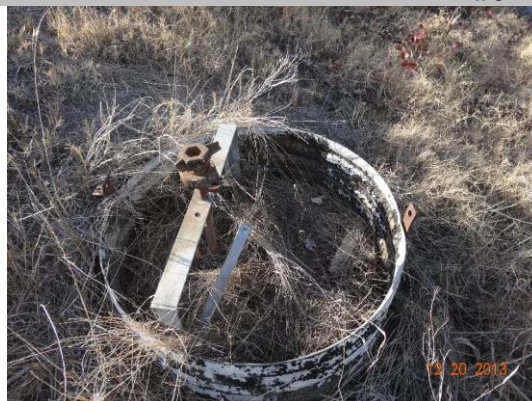
Photo 2 of 2 : UCIP_FA_2016_29329_54332.jpg

Comment Code						
Inspector Comment						
FS_ID:29329						
DS_ID:24384						
EP_NO: N/A						
Repair Type: Non-Urgent						
Crossing Status: Indicator Found						
UCIP Comments: Non-functional crossing--need to coordinate with owner, DWR-Inspector, and CVFPB to determine how to properly abandon crossing.						
FIELD_STRUCT_DESC: *ABANDONED* 24-inch pipe through the levee, 8.0 feet below the crown. Two CM cutoff walls around pipe. Slide gate in 30-inch CM riser and flap gate at waterside (WS) end. Concrete "U" headwall and splash apron on WS end. Landside (LS) end cutoff and plugged, riser filled with dirt. (USACE-1959). This entry matches the Drainage or Irrigation Structure referenced in O&M manual (Station 72+10).						
FS Date: 12/20/2013

Slide gate non-functional--riser filled with soil.

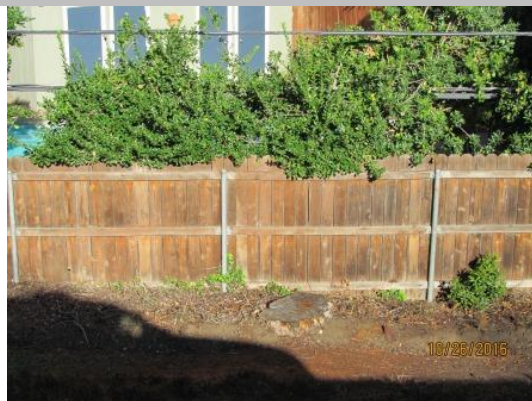
Photo 1 of 1 : FA_2016_NA0001_60_30_20161031_00044.jpg

LM Start	0.34	Rating **	N	Issue No.	30
LM End	0.34	Issue Type +	Ma	Location *	LS
Category	Earthen Levee			GPS Latitude/Longitude	
				Start	End
Item	Trim / Thin Trees			38.567267 °	38.567267 °
				-121.389069 °	-121.389069 °
DWR ID	DWR_NA0001_09_s_2016_30				
Comment Code					
T5 : Tree stumps.					
Inspector Comment

View of the tree stump on the landside levee toe.

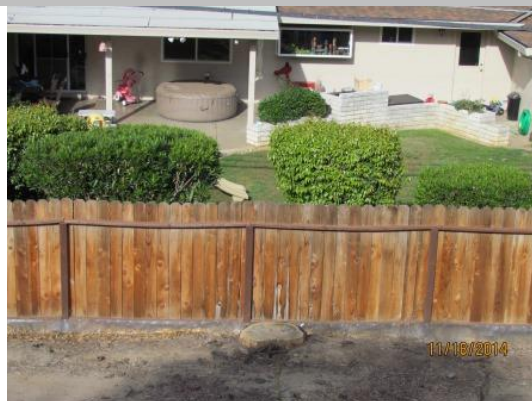
Photo 1 of 1 : FA_2016_NA0001_60_12_20160914_00003.jpg

LM Start	0.40	Rating **	N	Issue No.	12
LM End	0.40	Issue Type +	Ma	Location *	LS
Category	Earthen Levee			GPS Latitude/Longitude	
				Start	End
Item	Trim / Thin Trees			38.566725 °	38.566725 °
				-121.389935 °	-121.389935 °
DWR ID	DWR_NA0001_09_f_2013_12				
Comment Code					
T5 : Tree stumps.					
Inspector Comment

View of the tree stump at the landside levee toe.

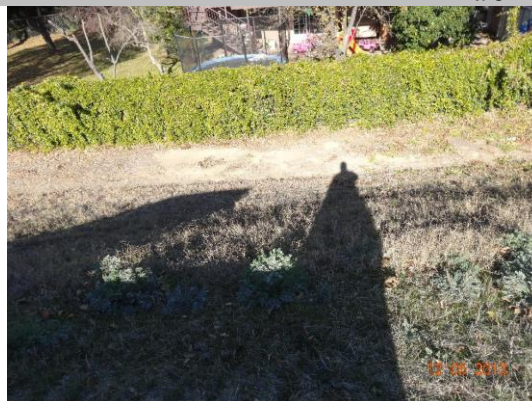
Photo 1 of 2 : UCIP_FA_2016_29347_54363.jpg

LM Start	1.29	Rating **	M	Issue No.	31
LM End	1.29	Issue Type +	En	Location *	LS
Category	Supplemental			GPS Latitude/Longitude	
				Start	End
Item	DWR UCIP Field Study			38.562285 °	38.562285 °
				-121.405265 °	-121.405265 °
DWR ID					
Comment Code					
Inspector Comment					
FS_ID:29347					
DS_ID:24394					
EP_NO: N/A					
Repair Type: Non-Urgent					
Crossing Status: Indicator Found					
UCIP Comments: Need to contact owner to determine status of crossing.					
FIELD_STRUCT_DESC: *ABANDONED* 12-inch steel pipe through the levee, 14.0 feet below the crown. Riser unit on waterside (WS). (USACE-1959). This entry matches the Drainage or Irrigation Structure referenced in O&M manual (Station 296+85). Pipe abandonment was referenced in Permit No. 4622 (1964).					
FS Date: 12/5/2013

View of landward side.

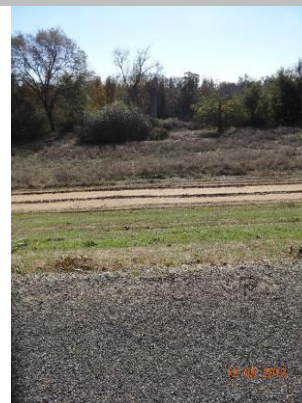
Photo 2 of 2 : UCIP_FA_2016_29347_54362.jpg

LM Start	1.29	Rating **	M	Issue No.	31 (cont)
LM End	1.29	Issue Type +	En	Location *	LS

View of waterward side--tall riser located approximately 200 feet away.

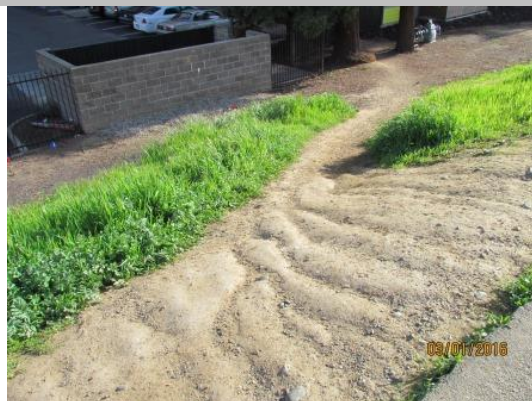
Photo 1 of 1 : FA_2016_NA0001_60_28_20160914_00007.jpg

LM Start	1.88	Rating **	A/W	Issue No.	28
LM End	1.88	Issue Type +	Ma	Location *	LS
Category	Earthen Levee			GPS Latitude/Longitude	
				Start	End
Item	Slope Stability			38.561171 °	38.561171 °
				-121.415808 °	-121.415808 °
DWR ID	DWR_NA0001_09_s_2016_28				
Comment Code					
S2 : Repair the levee slope damaged by foot traffic and prevent access where possible.					
Inspector Comment

View of the landside levee slope.

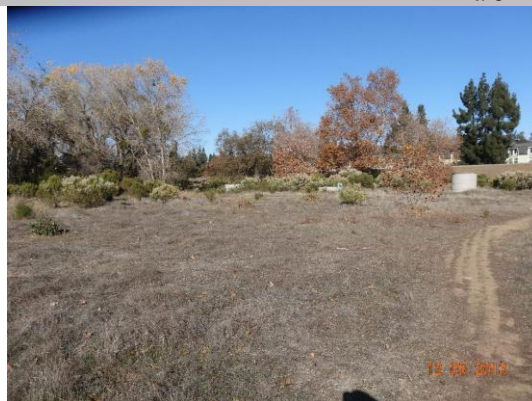
Photo 1 of 2 : UCIP_FA_2016_29351_54369.jpg

LM Start	1.93	Rating **	M	Issue No.	32
LM End	1.93	Issue Type +	En	Location *	LS
Category	Supplemental			GPS Latitude/Longitude	
				Start	End
Item	DWR UCIP Field Study			38.560889 °	38.560889 °
				-121.417196 °	-121.417196 °
DWR ID					
Comment Code					
Inspector Comment					
FS_ID:29351					
DS_ID:24597					
EP_NO: 17587					
Repair Type: Non-Urgent					
Crossing Status: Indicator Found					
UCIP Comments: Unable to confirm if riser belongs to this crossing--need to coordinate with owner to determine specifics. Description needs to be updated.					
FIELD_STRUCT_DESC: 54-inch water main through the levee at unknown depth. (Permit No. 17587-2003)					
FS Date: 12/5/2013

Three risers located on waterward berm.

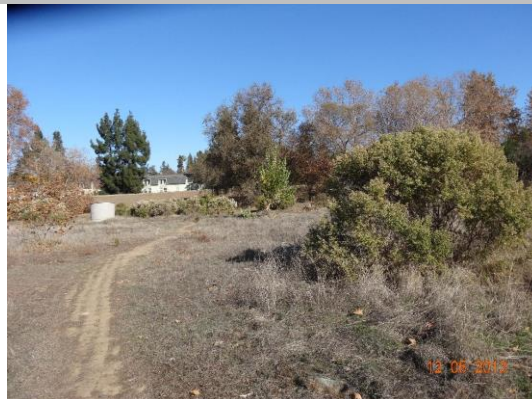
Photo 2 of 2 : UCIP_FA_2016_29351_54368.jpg

LM Start	1.93	Rating **	M	Issue No.	32 (cont)
LM End	1.93	Issue Type +	En	Location *	LS
Category	Supplemental			GPS Latitude/Longitude	
				Start	End
Item	DWR UCIP Field Study			38.560889 °	38.560889 °
				-121.417196 °	-121.417196 °
DWR ID					
Comment Code					
Inspector Comment					
FS_ID:29351 DS_ID:24597 EP_NO: 17587 Repair Type: Non-Urgent Crossing Status: Indicator Found UCIP Comments: Unable to confirm if riser belongs to this crossing--need to coordinate with owner to determine specifics. Description needs to be updated. FIELD_STRUCT_DESC: 54-inch water main through the levee at unknown depth. (Permit No. 17587-2003) FS Date: 12/5/2013

View of waterward berm looking toward levee crown from waterward berm edge.

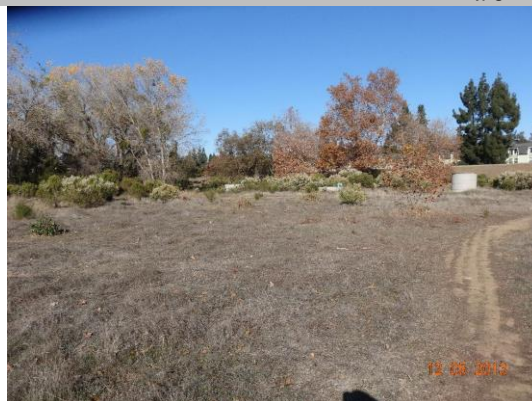
Photo 1 of 2 : UCIP_FA_2016_30124_55522.jpg

LM Start	1.95	Rating **	M	Issue No.	34
LM End	1.95	Issue Type +	En	Location *	LS
Category	Supplemental			GPS Latitude/Longitude	
				Start	End
Item	DWR UCIP Field Study			38.561064 °	38.561064 °
				-121.417323 °	-121.417323 °
DWR ID					
Comment Code					
Inspector Comment					
FS_ID:30124 DS_ID:24395 EP_NO: N/A Repair Type: Non-Urgent Crossing Status: Indicator Found UCIP Comments: unable to confirm crossing--need to contact owner to determine status of crossing. FIELD_STRUCT_DESC: 60-inch sewer main through the American River overflow area. Erosion protection and rock revetment on waterside (WS) slope added under Permit No. 14487 (1986). FS Date: 12/5/2013

View of berm on waterward side.

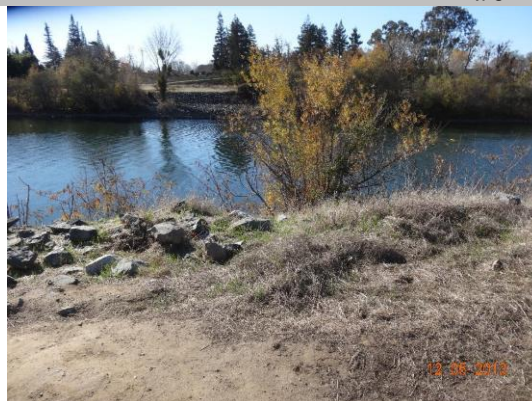
Photo 2 of 2 : UCIP_FA_2016_30124_55521.jpg

LM Start	1.95	Rating **	M	Issue No.	34 (cont)
LM End	1.95	Issue Type +	En	Location *	LS
Category	Supplemental			GPS Latitude/Longitude	
				Start	End
Item	DWR UCIP Field Study			38.561064 °	38.561064 °
				-121.417323 °	-121.417323 °
DWR ID					
Comment Code					
Inspector Comment					
FS_ID:30124 DS_ID:24395 EP_NO: N/A Repair Type: Non-Urgent Crossing Status: Indicator Found UCIP Comments: unable to confirm crossing--need to contact owner to determine status of crossing. FIELD_STRUCT_DESC: 60-inch sewer main through the American River overflow area. Erosion protection and rock revetment on waterside (WS) slope added under Permit No. 14487 (1986). FS Date: 12/5/2013

Rip rap used along waterward toe.

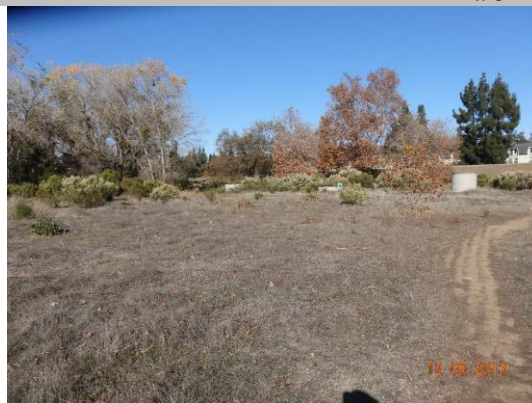
Photo 1 of 2 : UCIP_FA_2016_46085_54713.jpg

LM Start	1.96	Rating **	M	Issue No.	42
LM End	1.96	Issue Type +	En	Location *	LS
Category	Supplemental			GPS Latitude/Longitude	
				Start	End
Item	DWR UCIP Field Study			38.561119 °	38.561119 °
				-121.417581 °	-121.417581 °
DWR ID					
Comment Code					
Inspector Comment					
FS_ID:46085 DS_ID:24649 EP_NO: 12188 Repair Type: Non-Urgent Crossing Status: Indicator Found UCIP Comments: unable to confirm crossing--need to contact owner to determine specifics and status of crossing. FIELD_STRUCT_DESC: 60-inch steel sewer main under the levee, approximately 21.6 feet below the crown. Two concrete cutoff walls around pipe under each shoulder. (Permit No. 12188-1979) Erosion protection and rock revetment on waterside (WS) slope added under Permit No. 14487 (1986). FS Date: 12/5/2013

View of waterward berm.

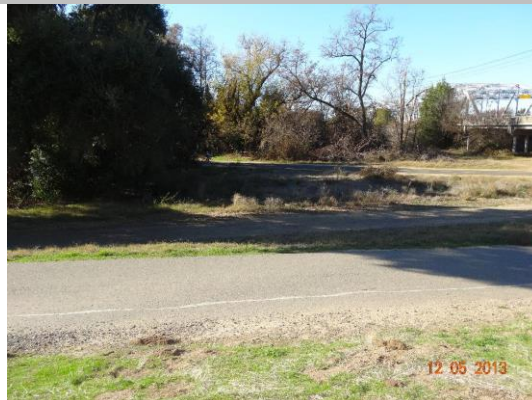
Photo 1 of 2 : UCIP_FA_2016_31309_57338.jpg

LM Start	2.51	Rating **	M	Issue No.	38
LM End	2.51	Issue Type +	En	Location *	LS
Category	Supplemental			GPS Latitude/Longitude	
				Start	End
Item	DWR UCIP Field Study			38.568767 °	38.568767 °
				-121.421178 °	-121.421178 °
DWR ID					
Comment Code					
Inspector Comment					
FS_ID:31309					
DS_ID:24515					
EP_NO: N/A					
Repair Type: Non-Urgent					
Crossing Status: Indicator Found					
UCIP Comments: Unable to confirm crossing. will need to contact owner to determine specifics and status of crossing.					
FIELD_STRUCT_DESC: 36-inch corrugated metal (CM) pipe through the levee. Riser unit on waterside (WS). (USACE-1959). This entry matches the Drainage or Irrigation Structure referenced in O&M manual (Station 365+14).					
FS Date: 12/5/2013

View of waterward side.

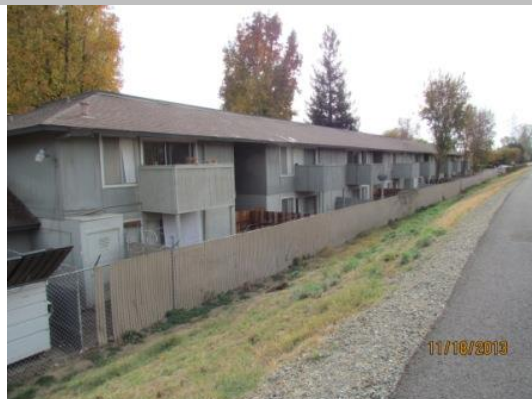
Photo 1 of 1 : FA_2016_NA0001_60_1_20160914_00001.jpg

LM Start	3.19	Rating **	U	Issue No.	1
LM End	3.27	Issue Type +	En	Location *	LS
Category	Earthen Levee			GPS Latitude/Longitude	
				Start	End
Item	Encroachments			38.578258 °	38.579363 °
				-121.418475 °	-121.418100 °
DWR ID	DWR_NA0001_09_s_2012_1				
Comment Code					
FE : Fence					
Inspector Comment

View of the fence at the landside levee toe.

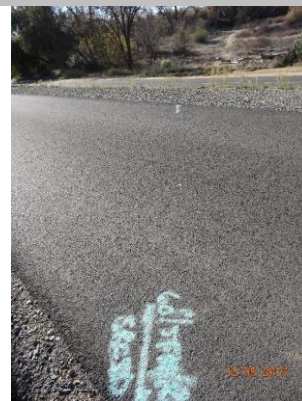
Photo 1 of 2 : UCIP_FA_2016_30125_55526.jpg

LM Start	3.32	Rating **	M	Issue No.	35
LM End	3.32	Issue Type +	En	Location *	LS
Category	Supplemental			GPS Latitude/Longitude	
				Start	End
Item	DWR UCIP Field Study			38.580094 °	38.580094 °
				-121.417821 °	-121.417821 °
DWR ID					
Comment Code					
Inspector Comment					
FS_ID:30125 DS_ID:24412 EP_NO: 17671 Repair Type: Non-Urgent Crossing Status: Indicator Found UCIP Comments: unable to confirm if manhole is part of this crossing-- need to contact owner to determine status of crossing. FIELD_STRUCT_DESC: 1 of 2: 60-inch sewer main under the levee. Connects to 60-inch main on landside (LS). (Permit No. 17671-2003) FS Date: 12/5/2013

View of waterward side.

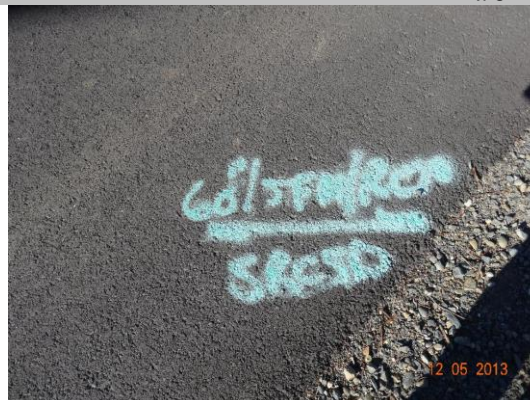
Photo 2 of 2 : UCIP_FA_2016_30125_55528.jpg

Underground service alert (USA) paint found on bike path on waterward side.

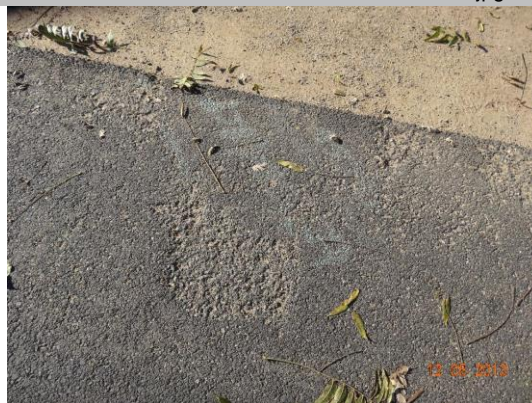
Photo 2 of 2 : UCIP_FA_2016_29633_54790.jpg

LM Start	3.34	Rating **	M	Issue No.	33
LM End	3.34	Issue Type +	En	Location *	LS
Category	Supplemental			GPS Latitude/Longitude	
				Start	End
Item	DWR UCIP Field Study			38.580347 °	38.580347 °
				-121.417734 °	-121.417734 °
DWR ID					
Comment Code					
Inspector Comment					
FS_ID:29633 DS_ID:24404 EP_NO: 12188 Repair Type: Non-Urgent Crossing Status: Indicator Found UCIP Comments: unable to confirm if crossing is still active--need to contact owner to determine status of crossing. FIELD_STRUCT_DESC: 60-inch concrete encased steel sewer line through the levee, 17.0 feet below the crown. Cutoff wall around pipe at the center of the levee. Rock revetment on waterside (WS) slope. Three pressure manholes in overflow area along pipe path. (Permit No. 12188-1979) FS Date: 12/5/2013

Underground service alert (USA) markings still present on levee crown.

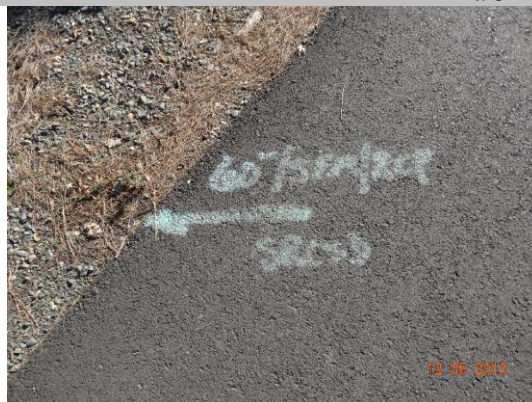
Photo 2 of 2 : UCIP_FA_2016_41437_55531.jpg

FS_ID:41437
DS_ID:24566
EP_NO: 17671
Repair Type: Non-Urgent
Crossing Status: Indicator Found
UCIP Comments: Need to confirm location with owner.
FIELD_STRUCT_DESC: 2 of 2: 60-inch sewer main under the levee.
Connects to 60-inch main on landside (LS). (Permit No. 17671-2003)
FS Date: 12/5/2013

Underground service alert (USA) markings found on levee crown for 60-inch pipe.

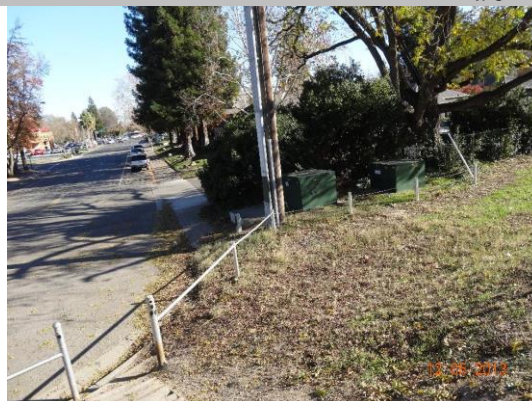
Photo 1 of 2 : UCIP_FA_2016_30684_56473.jpg

FS_ID:30684
DS_ID:24816
EP_NO: N/A
Repair Type: Non-Urgent
Crossing Status: Indicator Found
UCIP Comments: unable to determine if crossing goes through levee.
Need to obtain additional information to confirm crossing.
FIELD_STRUCT_DESC: Water fountain found on waterside (WS).
FS Date: 12/5/2013

View of landward side.

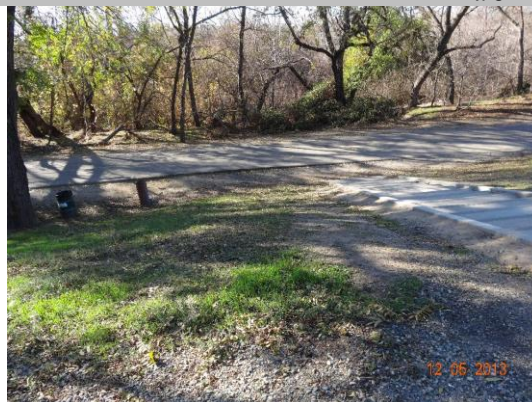
Photo 2 of 2 : UCIP_FA_2016_30684_56472.jpg

View of waterward side.

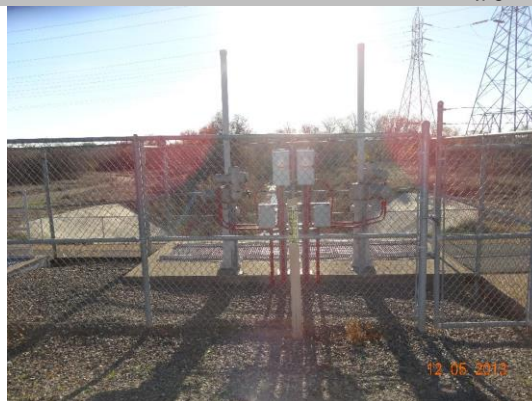
Photo 1 of 2 : UCIP_FA_2016_31304_57325.jpg

LM Start	3.68	Rating **	M	Issue No.	40
LM End	3.68	Issue Type +	En	Location *	LS
Category	Supplemental			GPS Latitude/Longitude	
				Start	End
Item	DWR UCIP Field Study			38.584344 °	38.584344 °
				-121.420968 °	-121.420968 °
DWR ID					
Comment Code					
Inspector Comment					
FS_ID:31304 DS_ID:24817 EP_NO: N/A Repair Type: Non-Urgent Crossing Status: Found UCIP Comments: Need to confirm crossing size--need additional information about crossing. FIELD_STRUCT_DESC: 1 of 2: Crossing through levee at unknown depth. Concrete structure (7x15-foot) located on waterside (WS) shoulder with slide gate inside manhole. Square flap gate located on WS end. Concrete wings and apron at WS end of outlet channel. Concrete box located on the WS shoulder fenced off. FS Date: 12/5/2013

Concrete box and electrical box located on waterward shoulder.

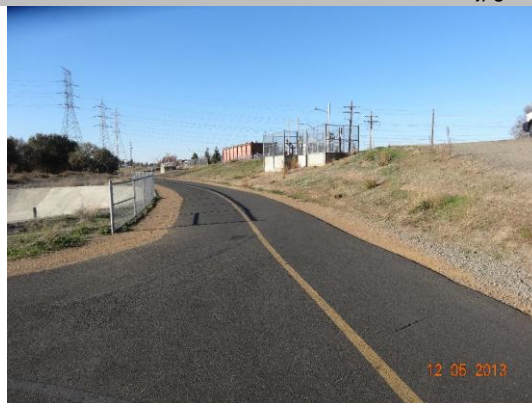
Photo 2 of 2 : UCIP_FA_2016_31304_57320.jpg

Bike path located on waterward side.

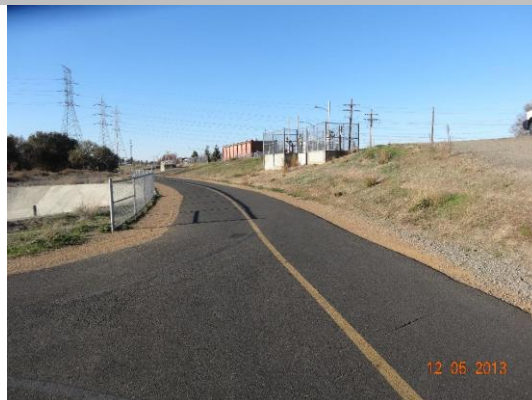
Photo 2 of 2 : UCIP_FA_2016_31306_57328.jpg

LM Start	3.69	Rating **	M	Issue No.	36
LM End	3.69	Issue Type +	En	Location *	LS
Category	Supplemental			GPS Latitude/Longitude	
				Start	End
Item	DWR UCIP Field Study			38.584355 °	38.584355 °
				-121.420989 °	-121.420989 °
DWR ID					
Comment Code					
Inspector Comment					
FS_ID:31306 DS_ID:24818 EP_NO: N/A Repair Type: Non-Urgent Crossing Status: Found UCIP Comments: Unable to confirm pipe size--need additional information about crossing. FIELD_STRUCT_DESC: 2 of 2: Crossing through levee at unknown depth. Concrete structure (7x15-foot) located on waterside (WS) shoulder with slide gate inside manhole. Square flap gate located on WS end. Concrete wings and apron at WS end of outlet channel. Concrete box located on the WS shoulder fenced off. No permit was found for this crossing. FS Date: 12/5/2013

Bike path located on waterward side.

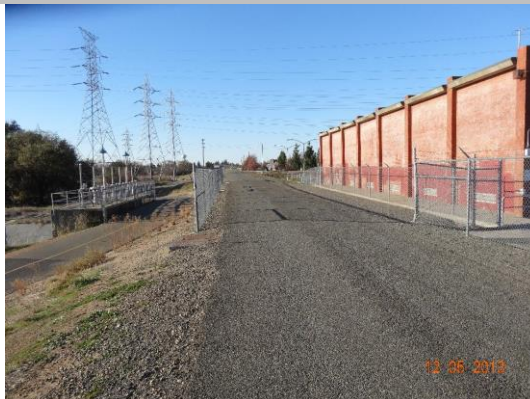
Photo 1 of 2 : UCIP_FA_2016_31307_57335.jpg

LM Start	3.72	Rating **	M	Issue No.	37
LM End	3.72	Issue Type +	En	Location *	LS
Category	Supplemental			GPS Latitude/Longitude	
				Start	End
Item	DWR UCIP Field Study			38.584710 °	38.584710 °
				-121.421496 °	-121.421496 °
DWR ID					
Comment Code					
Inspector Comment					
FS_ID:31307					
DS_ID:24819					
EP_NO: N/A					
Repair Type: Non-Urgent					
Crossing Status: Found					
UCIP Comments: Unable to confirm is pipe crosses levee--no permit available.					
FIELD_STRUCT_DESC: Service box located on waterside (WS) and landside (LS). Unable to confirm crossing exists through levee. No permit found for this potential crossing.					
FS Date: 12/5/2013

View of concrete service box located on waterward shoulder.

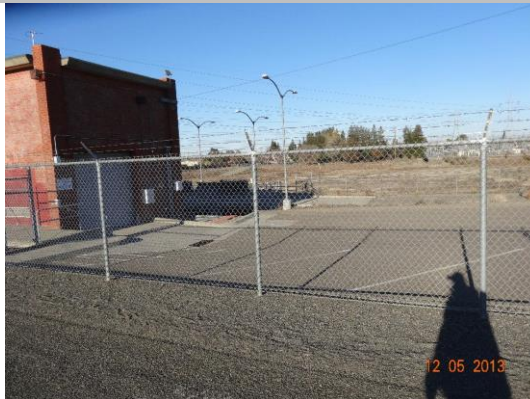
Photo 2 of 2 : UCIP_FA_2016_31307_57334.jpg

Concrete box located inside fenced area located on landward side.

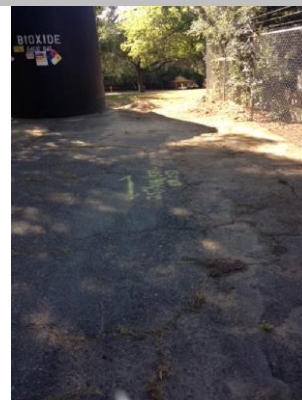
Photo 1 of 2 : UCIP_FA_2016_50053_75902.jpg

LM Start		Rating **	M	Issue No.	131
LM End		Issue Type +	En	Location *	LS
Category	Supplemental		GPS Latitude/Longitude		
			Start	End	
Item	DWR UCIP Field Study		38.583728 °	38.583728 °	
			-121.340178 °	-121.340178 °	
DWR ID					
Comment Code					
Inspector Comment					
FS_ID:50053 DS_ID:25449 EP_NO: N/A Repair Type: Non-Urgent Crossing Status: Indicator Found UCIP Comments: FIELD_STRUCT_DESC: 3-inch diameter plastic vynal conduit chlorine line sleeved through steel pipe through the right bank of the levee 2 feet below crown. (Permit No. 4535-1964, Northeast Sacramento County Sanitation District) Contact: Sacramento Regional Office 875-9400; Oscar Starks (Supervisor) 916-204-5143; Troy Shurock 916-599-2413. FS Date: 4/1/2016

WS View - underground service alert (USA) markings indicating pipe alignment.

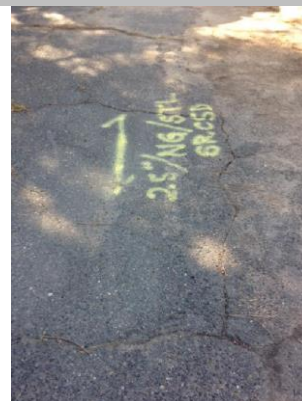
Photo 2 of 2 : UCIP_FA_2016_50053_75903.jpg

LM Start		Rating **	M	Issue No.	131 (cont)	
LM End		Issue Type +	En	Location *	LS	
Category	Supplemental			GPS Latitude/Longitude		
				Start	End	
Item	DWR UCIP Field Study			38.583728 °	38.583728 °	
				-121.340178 °	-121.340178 °	
DWR ID						
Comment Code						
Inspector Comment						
FS_ID:50053						
DS_ID:25449						
EP_NO: N/A						
Repair Type: Non-Urgent						
Crossing Status: Indicator Found						
UCIP Comments:						
FIELD_STRUCT_DESC: 3-inch diameter plastic vynal conduit chlorine line sleeved through steel pipe through the right bank of the levee 2 feet below crown. (Permit No. 4535-1964, Northeast Sacramento County Sanitation District) Contact: Sacramento Reginal Office 875-9400; Oscar Starks (Supervisor) 916-204-5143; Troy Shurock 916-599-2413.						
FS Date: 4/1/2016

USA markings indicate 2.5-inch steel line.

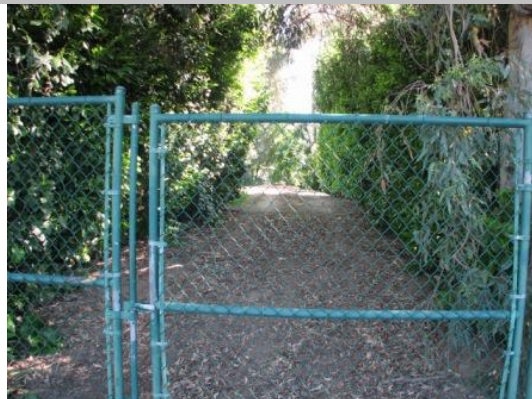
Photo 1 of 1 : FA_2016_NA0001_61_16_20160914_00004.jpg

LM Start	0.00	Rating **	U	Issue No.	16
LM End	0.62	Issue Type +	En	Location *	CR
Category	Earthen Levee			GPS Latitude/Longitude	
				Start	End
Item	Encroachments			38.600917 °	38.592184 °
				-121.332100 °	-121.334347 °
DWR ID	DWR_NA0001_10_s_2012_16				
Comment Code					
UR : Urban					
Inspector Comment

Levee encroached on by property owners north of Arden Way. This section is not reasonably accessible.

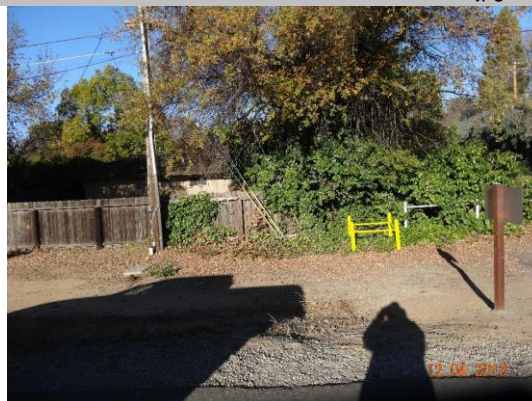
Photo 1 of 2 : UCIP_FA_2016_31450_57501.jpg

LM Start	0.62	Rating **	M	Issue No.	122
LM End	0.62	Issue Type +	En	Location *	CR
Category	Supplemental			GPS Latitude/Longitude	
				Start	End
Item	DWR UCIP Field Study			38.592105 °	38.592105 °
				-121.334423 °	-121.334423 °
DWR ID					
Comment Code					
Inspector Comment					
FS_ID:31450					
DS_ID:24820					
EP_NO: N/A					
Repair Type: Non-Urgent					
Crossing Status: Indicator Found					
UCIP Comments: Unable to determine alignment of crossing, does it cross levee? Permit?					
FIELD_STRUCT_DESC: Protective posts located on landside (LS) for what appears to be for gas/petroleum line. Unable to confirm if line goes through levee or if line runs parallel. No permit found.					
FS Date: 12/4/2013

View of protective posts located on landward side.
